TECHNICAL REPORT NO. 6-570 -

DURABILITY AND BEHAVIOR OF PRESTRESSED CONCRETE BEAMS

LABORATORY TESTS OF WEATHERED PRETENSIONED BEAMS

June 1976

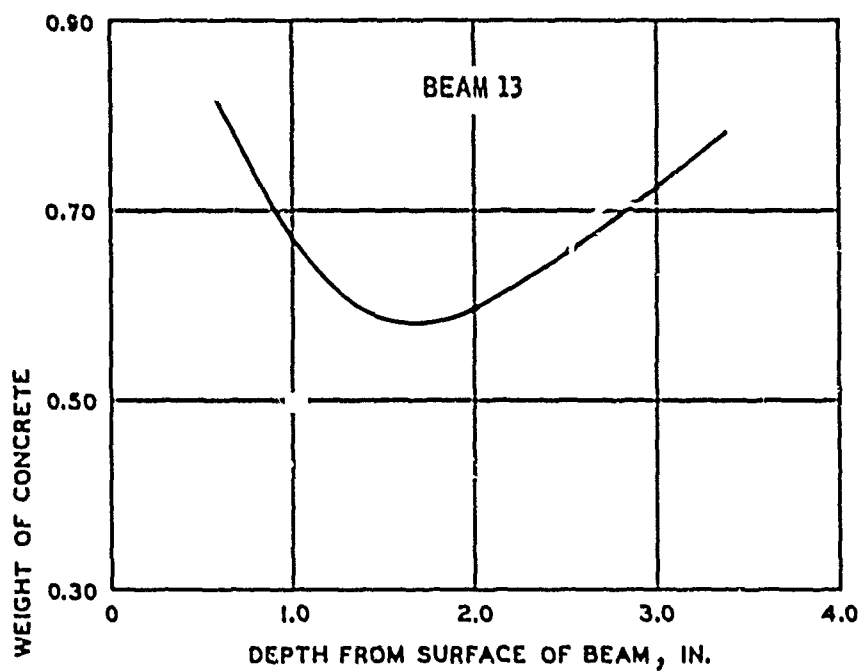
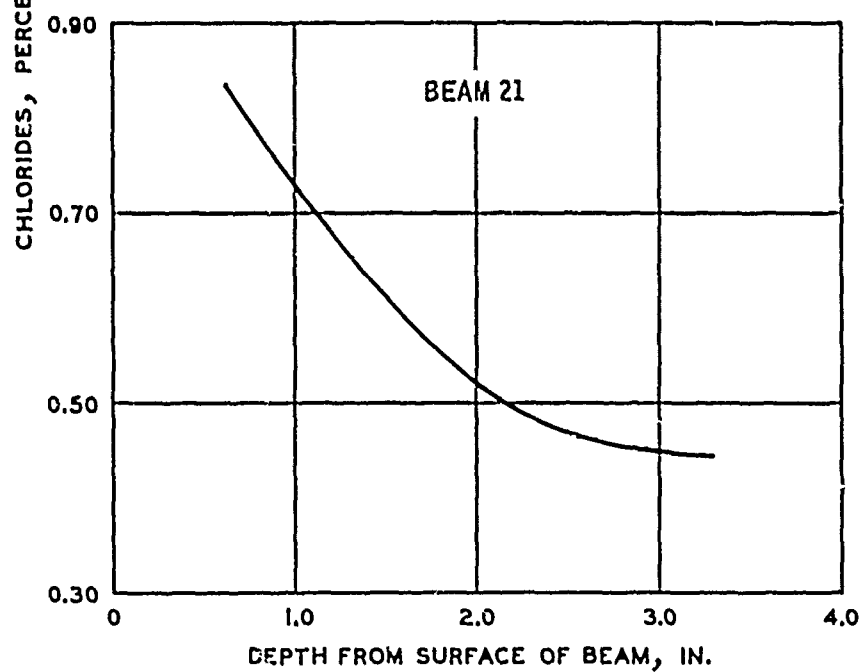
CHLORIDE CONTENT
VERSUS DEPTH

32. The concrete was analyzed for chloride content using the silver nitrate titration procedure described by Berman.⁷ The chloride contents reported ranged from 0.443 to 0.839 percent by weight of concrete. Plate 2 shows that chloride content decreases with depth in beam 21 but not in beam 13, where an initial decline was followed by an increase. This relation was previously observed by Roshore (Reference 3) in specimens from St. Augustine.
